Shock Tube Testing of CL-700 & LCL-800 Film with C-Bond Adhesive

May 2011
San Antonio, Texas

ABS Consulting Project Number 2548874

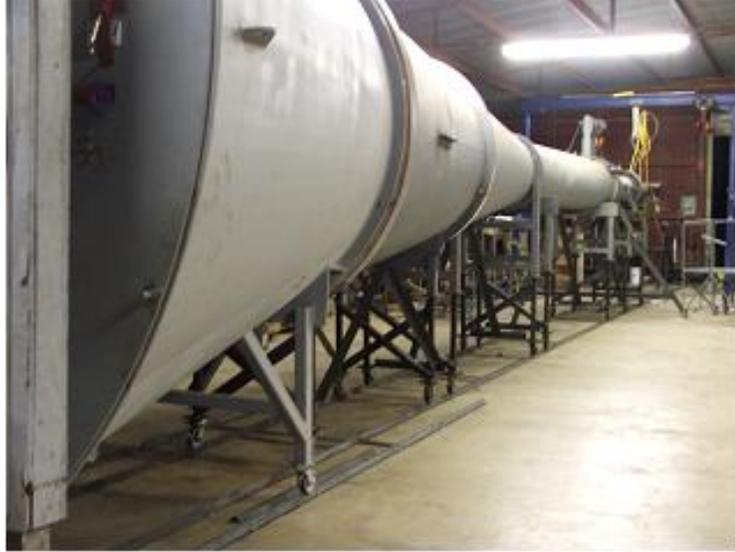
Figure 1. ABS Consulting Shock Tube Apparatus

Blast loads were applied using a “shock tube” as shown in Figure 1. This device uses a sudden burst of compressed air to create a blast pulse, which travels down the tube and is applied to the test specimen which is secured to the end of the tube. An enclosure (test cubicle) is attached to the end of the tube. The blast load creates a specified positive blast pressure and impulse on the test specimens. Negative phase blast loads may occur but the system is not designed to produce a negative pulse typical of a high explosive load. Testing commenced with blast loads designed to meet the various threat – standoff combinations as described in the UFC. The same blast pressure was applied to each specimen.

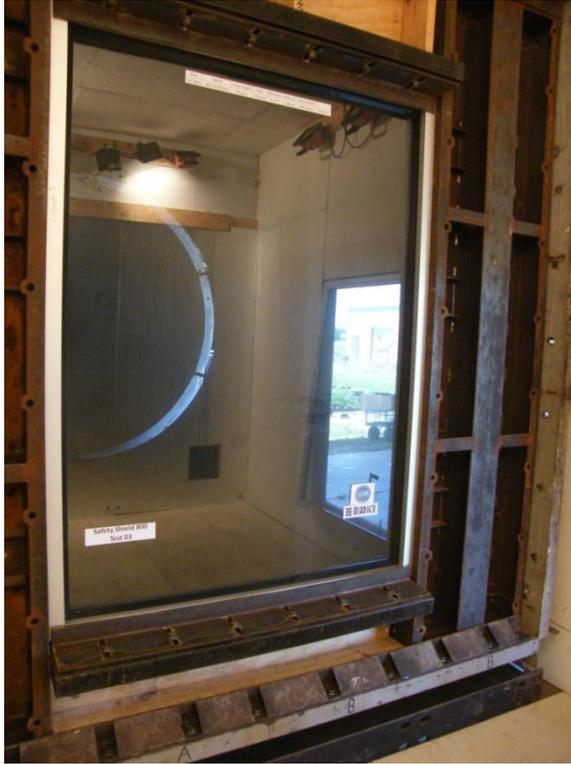
Figure 2. Window Mounted in Test Fixture

Window frame assemblies were installed into the shock tube. Steel angles and plates were used to support the frame to prevent lateral displacement. This configuration simulates a window system installed in the field through the head and sill only.

Figure 2 shows a window mounted in the ABS shock tube. A close-up view of the shock tube mounting restraint is shown in Figure 3.

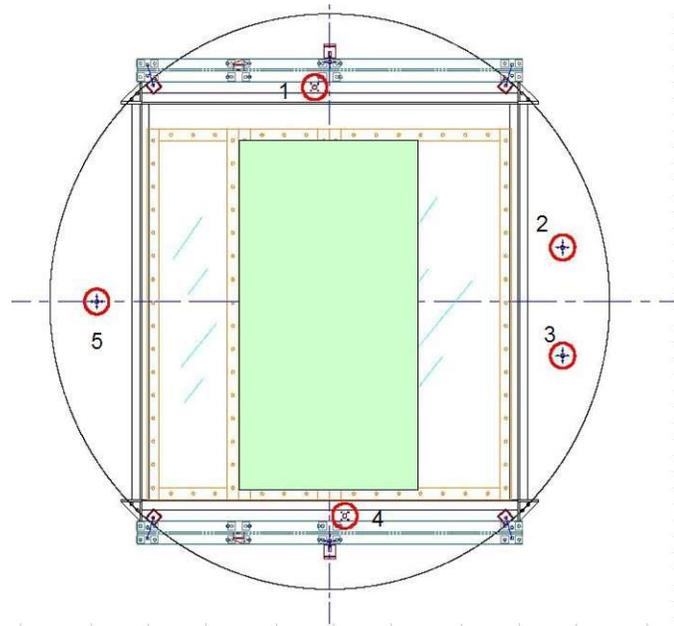
Figure 4. Pressure Gauge Locations

Blast pressure gauges (gauges 1-5) measuring applied pressure were mounted on the shock tube bulkhead facing the oncoming blast wave, immediately adjacent to the test specimen (see Figure 4). A blast gauge (gauge 6) was also mounted inside the test cubicle to measure internal incident blast pressure. Blast pressures gauges were PCB 102A piezoelectric type calibrated for 0-10 psi peak pressure range. Pressure waveforms were recorded by a Yokogawa DL series digital scope sampling at a minimum of 500 kHz.

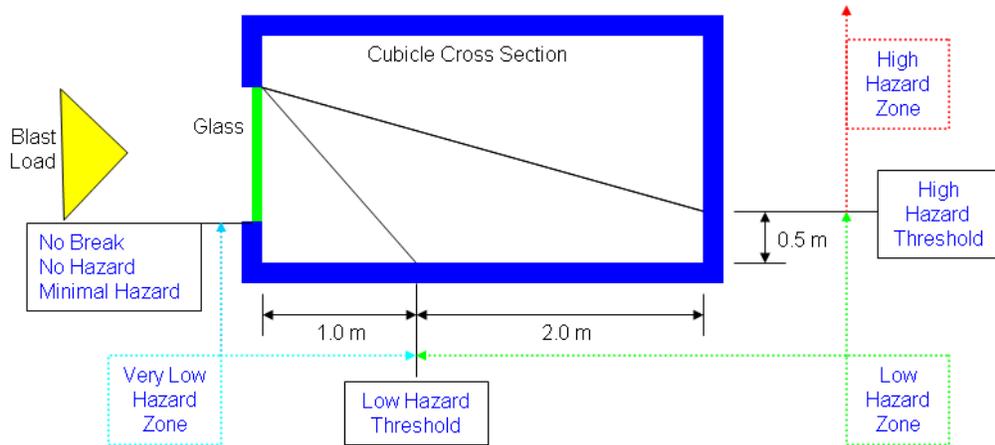
Figure 5. ASTM F1642-04 Performance Criteria

Following each test, glass fragments were collected and the unified dimensions of fragments projected into the test cubicle were determined for classification per the ASTM 1642 protocol. Fragments striking and embedding in the witness panel were collected and documented. Frame deflections were recorded and performance of framing was documented. Performance conditions for each test item were assigned and recorded in accordance with ASTM 1642-04 and the GSA criteria as shown in Figure 5 and Figure 6, respectively.

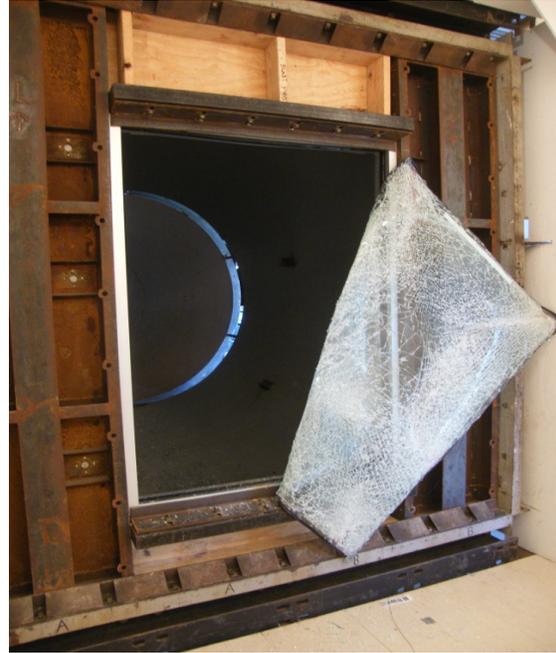
Post-Test Photograph

Notes:	0 - 40 in Fragments	40 - 120 in Fragments < 100g	
United Dimension (in):	Multiple	<10	
Tears and Pullout:	Interior 7%	Perimeter 80%	Sum 87%
Witness Panel Perforations/Indents:	Low Hazard/Zone 4 None	High Hazard/Zone 5 None	
Witness Panel Penetrations:	None	None	
Notes:	Glazing fractured and silicone failed along the sill, head and one jamb. The filmed glass remained attached to one frame jamb. Silicone failure was predominately cohesive. No glass impacts on the witness panel.		
GSA Performance Condition:	3B	ASTM F-1642 Hazard Level:	Very Low

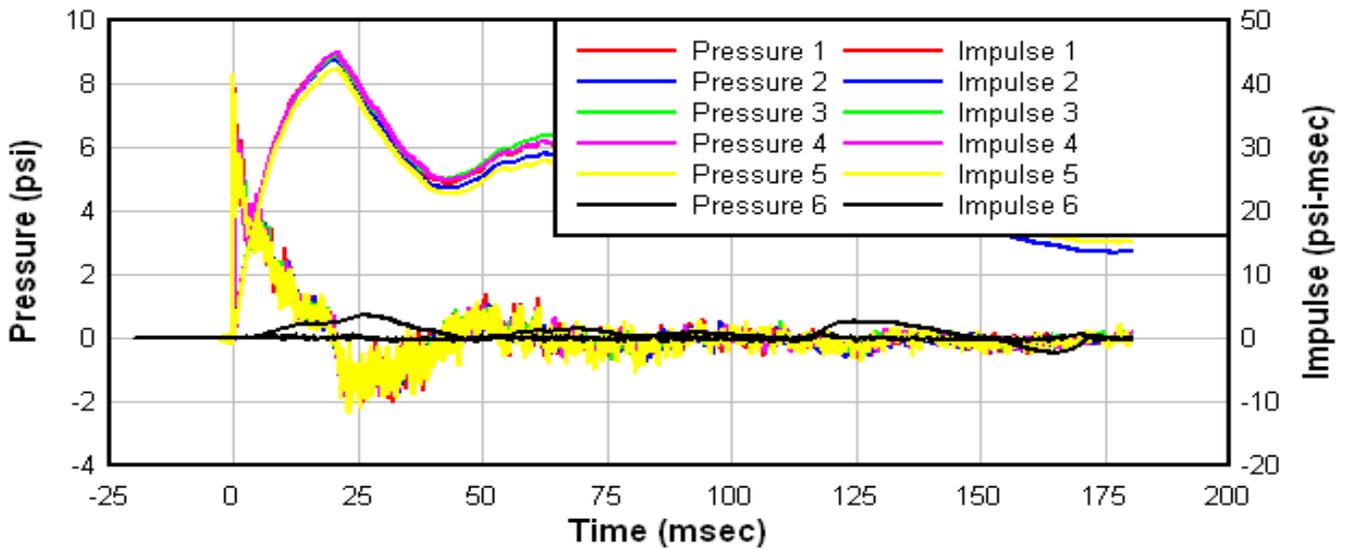
Test 01 (04/12/11) - Pressure Data

C-Bond / Madico LCL 800

295psi - 6.5ft Driver - 12.0 / 0.0 / 2.5

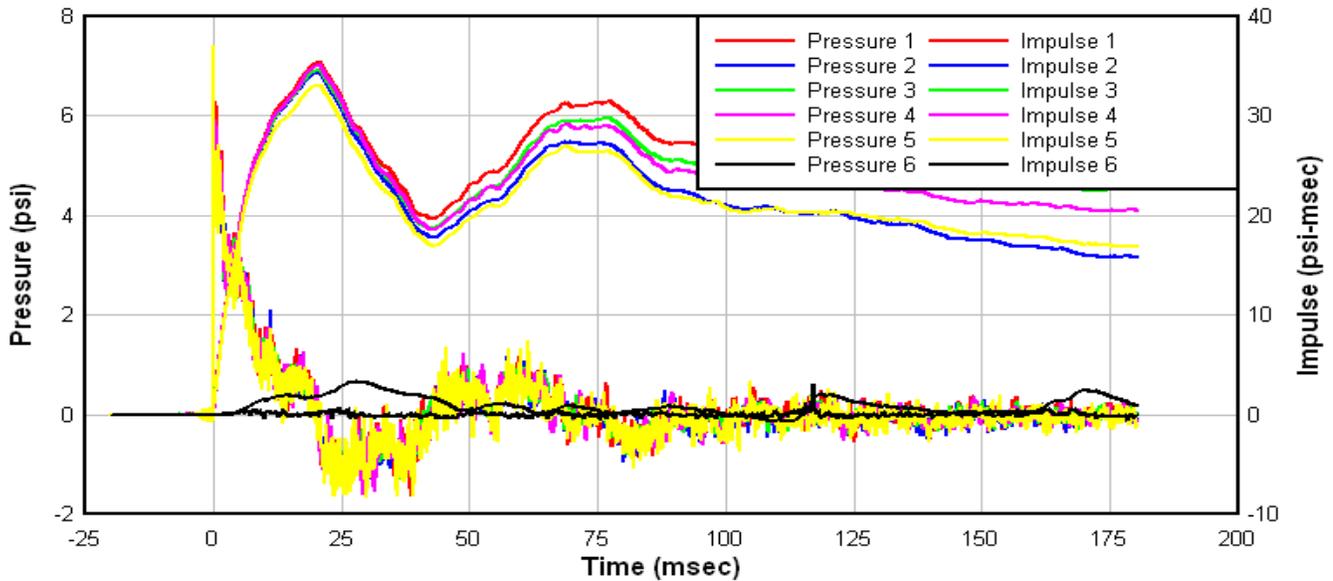
Test 02 (04/12/11) - Pressure Data
286psi - 6.0ft Driver - 12.0 / 3.0 / 2.5

C-Bond / Madico LCL 800

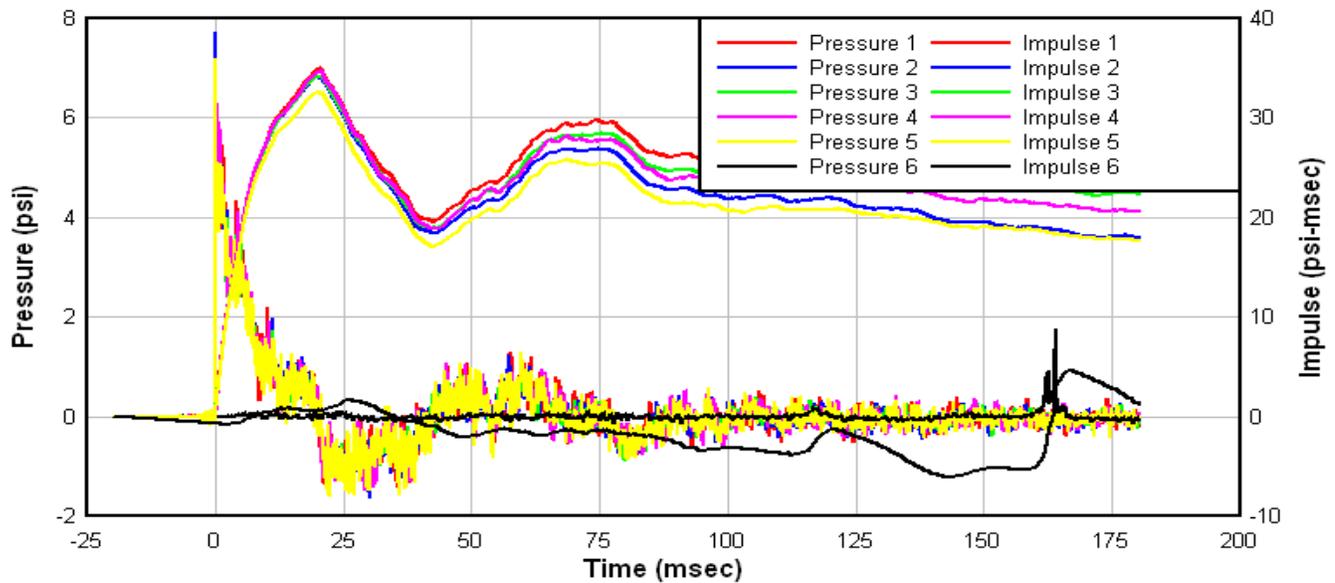
Test 03 (04/12/11) - Pressure Data
284psi - 6.0ft Driver - 12.0 / 3.0 / 2.5

C-Bond / Madico LCL 800

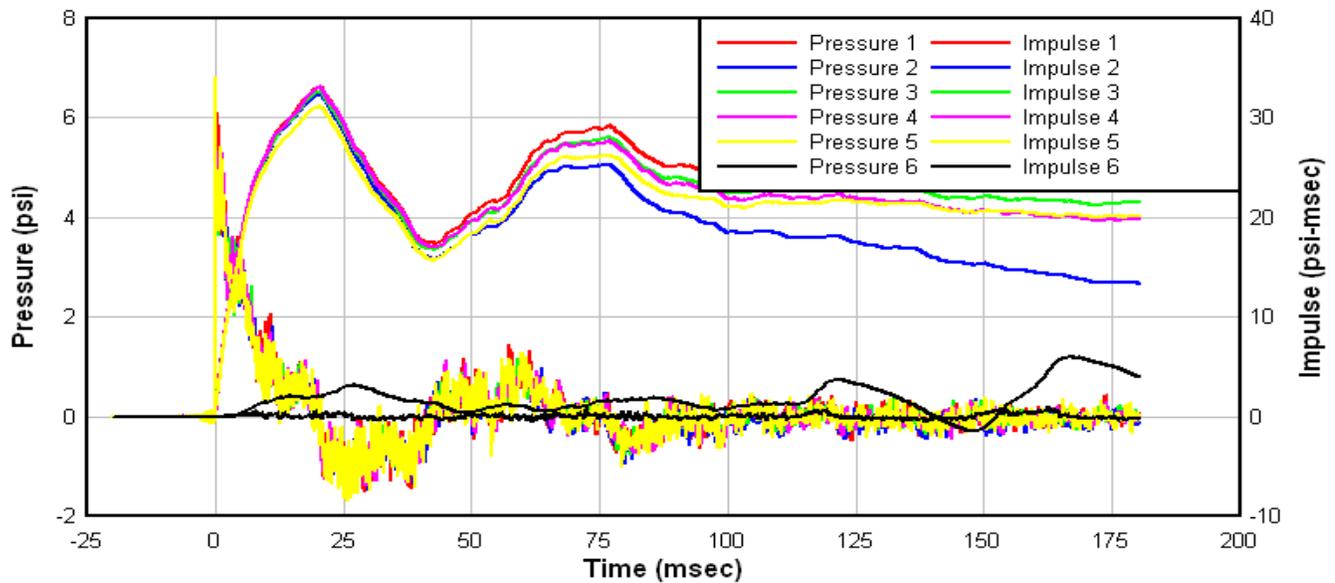
Test 04 (04/12/11) - Pressure Data
270psi - 6.0ft Driver - 12.0 / 3.0 / 2.5

C-Bond / Madico LCL 800

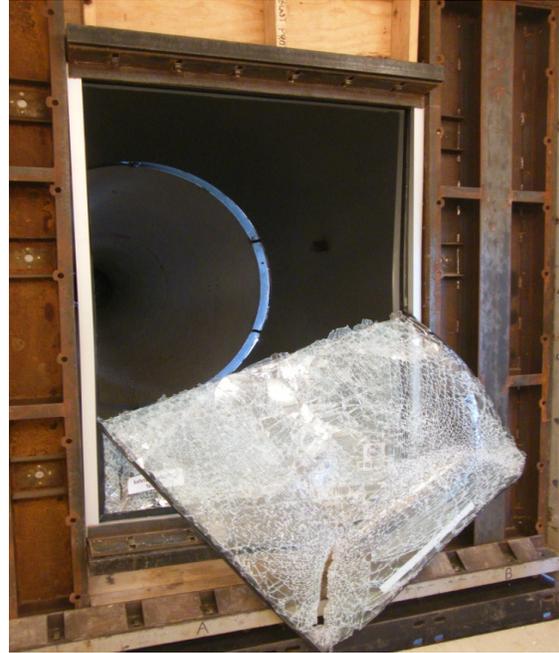
Post-Test Photograph

Notes:	0 - 40 in Fragments	40 - 120 in Fragments	
United Dimension (in):	>10	>10	
Tears and Pullout:	Interior 0%	Perimeter 70%	Sum 70%
Witness Panel Perforations/Indents:	Low Hazard/Zone 4 >10	High Hazard/Zone 5 >5	
Witness Panel Penetrations:			
Notes:	Glazing fractured and silicone failed along the head and over 60% of the jambs. The filmed glass folded over into cubicle. Silicone failure was predominately cohesive. Large number of fragment impacts were recorded on the witness panel.		
GSA Performance Condition:	5	ASTM F-1642 Hazard Level:	High

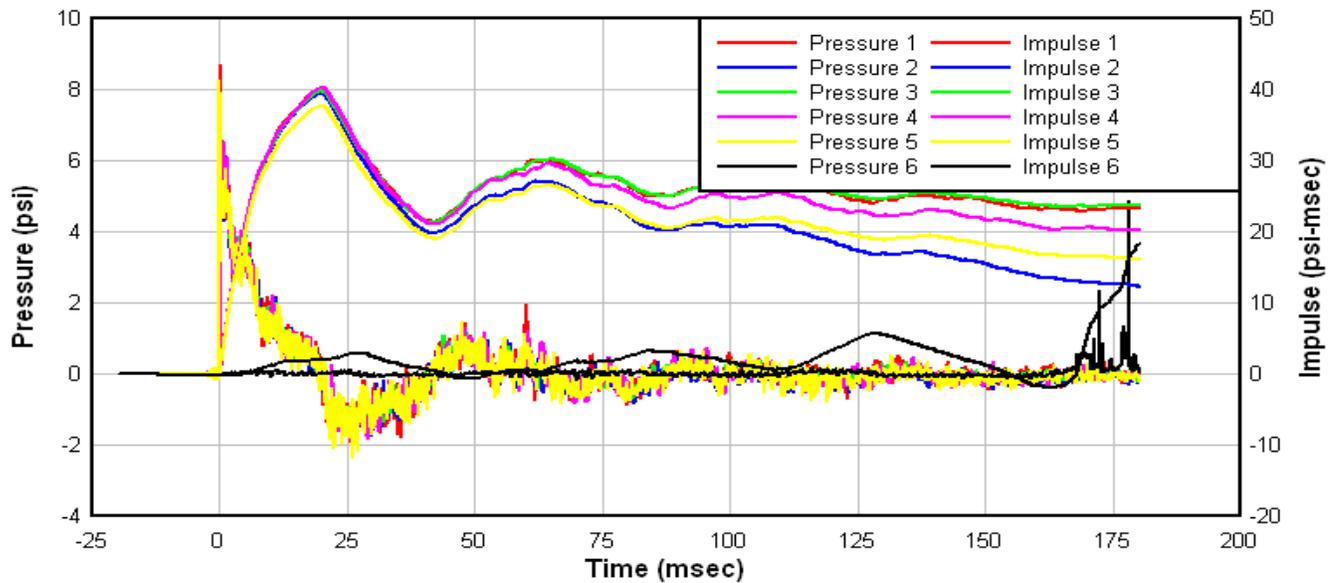
Test 05 (04/12/11) - Pressure Data
279psi - 6.0ft Driver - 12.0 / 0.0 / 2.5

C-Bond / Madico LCL 800

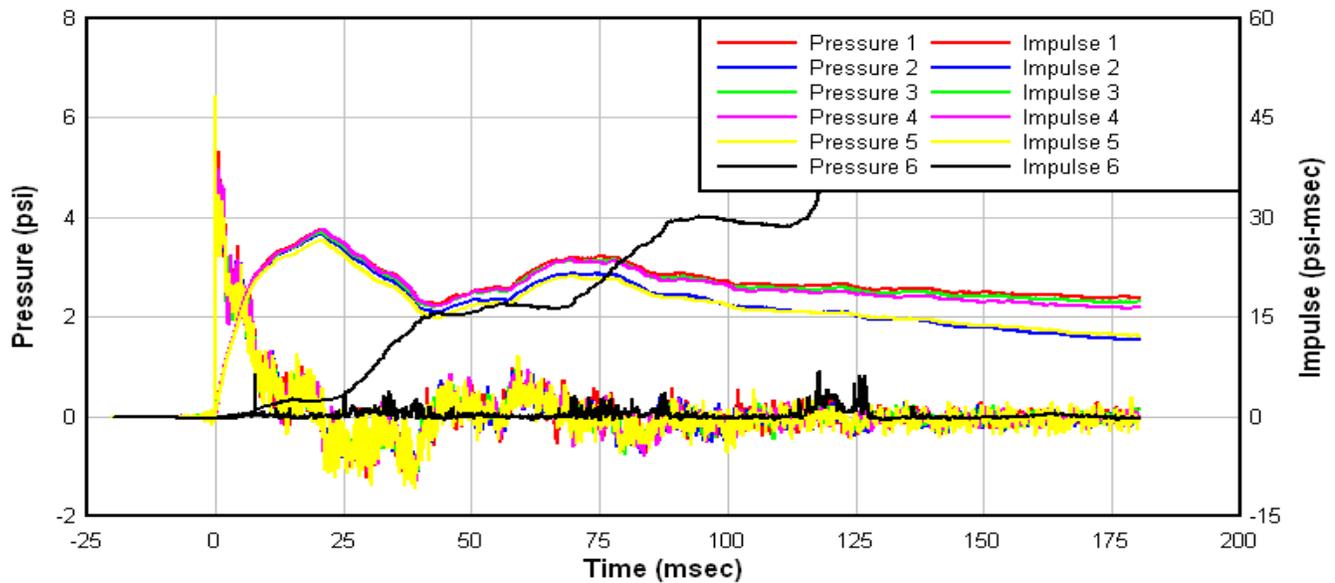
Test 06 (04/13/11) - Pressure Data
278psi - 6.0ft Driver - 12.0 / 6.5 / 2.5

C-Bond / Madico CL 700

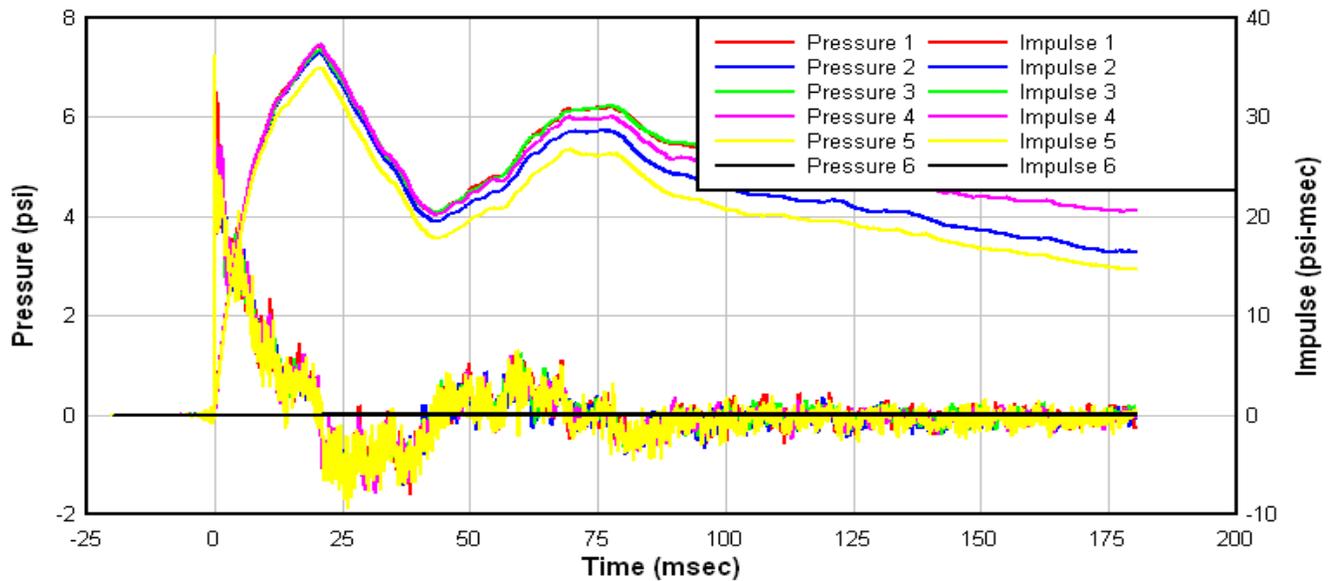
Test 07 (04/13/11) - Pressure Data
285psi - 6.5ft Driver - 12.0 / 3.0 / 2.5

C-Bond / Madico CL 700

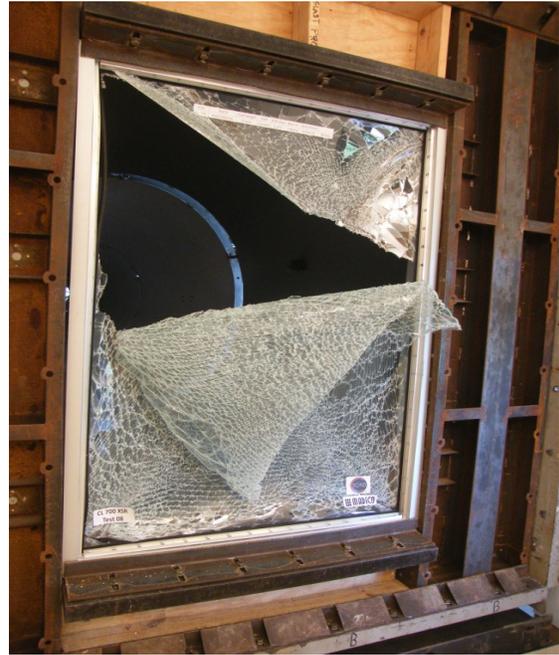
Post-Test Photograph

Notes:	0 - 40 in Dusting & Frags	40 - 120 in Small Frags	
United Dimension (in):	<1	11	
Tears and Pullout:	Interior 25%	Perimeter 12%	Sum 37%
Witness Panel Perforations/Indents:	Low Hazard/Zone 4 Multiple	High Hazard/Zone 5 32	
Witness Panel Penetrations:	None	None	
Notes:	Glazing fractured and film split open from top corner to opposite side a mid-height. A large number of fragments were released into the cubicle and numerous impacts were recorded on the witness panel.		
GSA Performance Condition:	5	ASTM F-1642 Hazard Level:	High

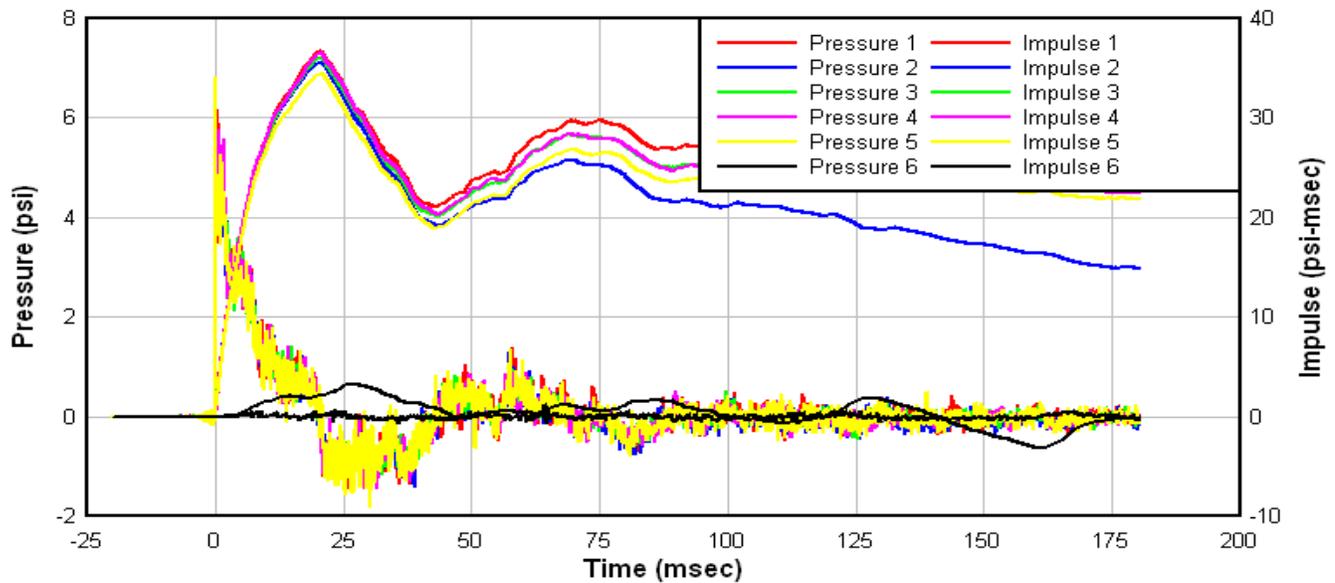
Test 08 (04/13/11) - Pressure Data
286psi - 6.5ft Driver - 12.0 / 3.0 / 2.5

C-Bond / Madico CL 700

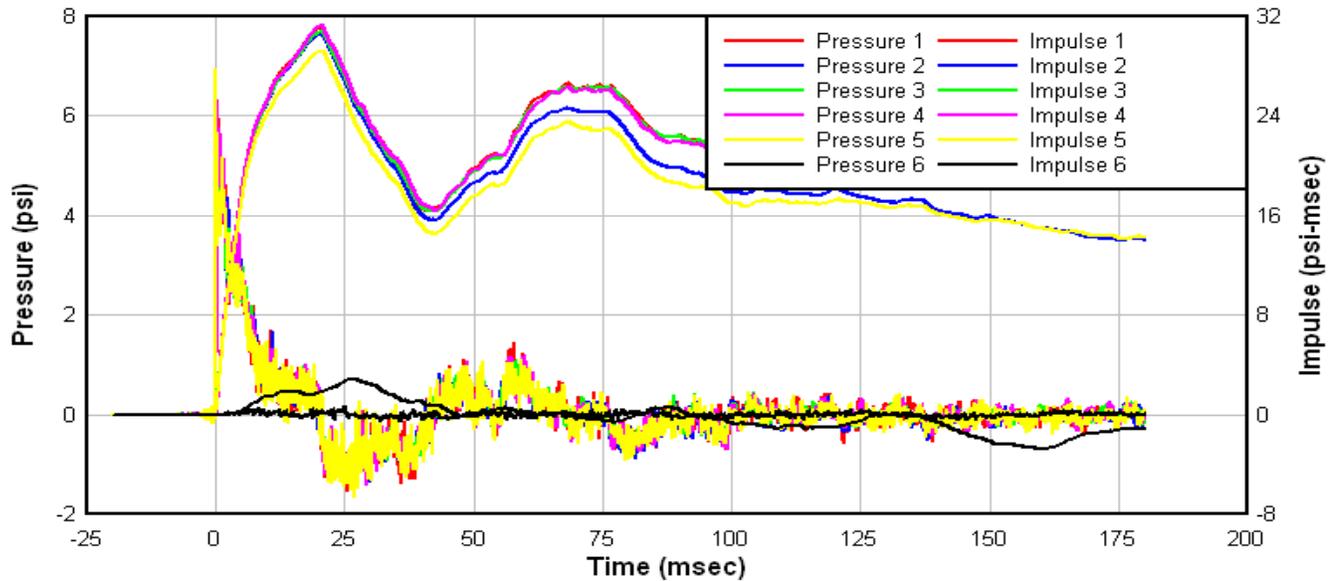
Test 09 (04/13/11) - Pressure Data
275psi - 5.5ft Driver - 12.0 / 3.0 / 2.5

C-Bond / Madico CL 700

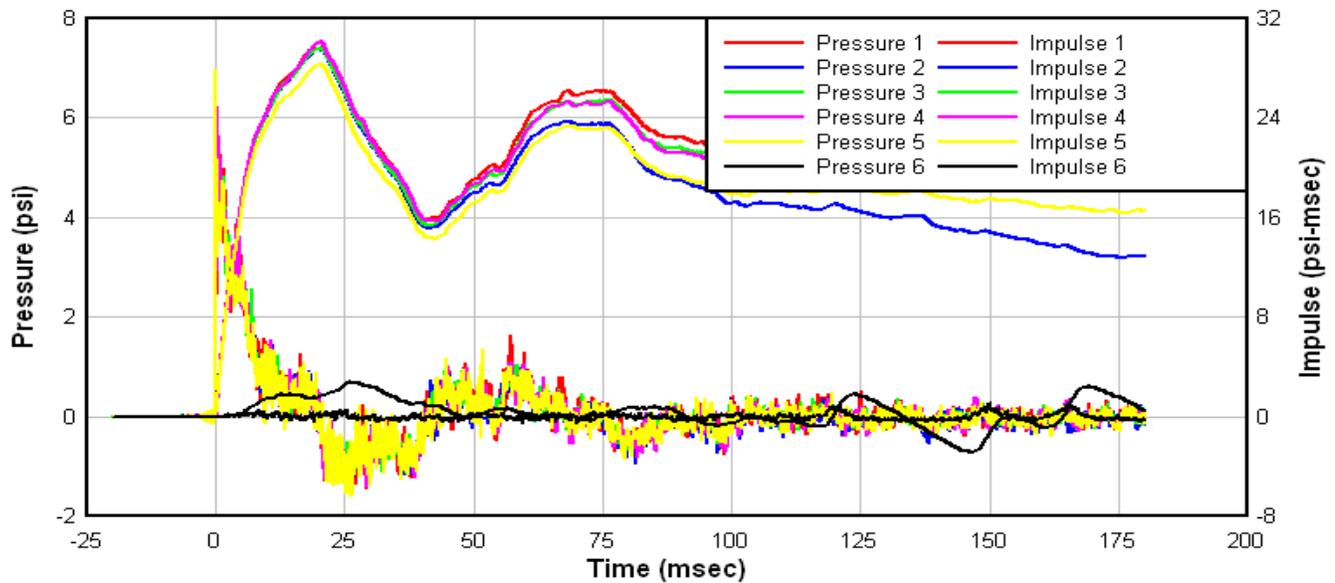
Test 10 (04/13/11) - Pressure Data

C-Bond / Madico CL 700

264psi - 5.5ft Driver - 12.0 / 3.0 / 2.5
